# Air Force Research Laboratory | AFRL

## **Success Story**

### **MATERIALS ENGINEERS IMPROVE RELIABILITY OF C-17 LANDING GEAR**

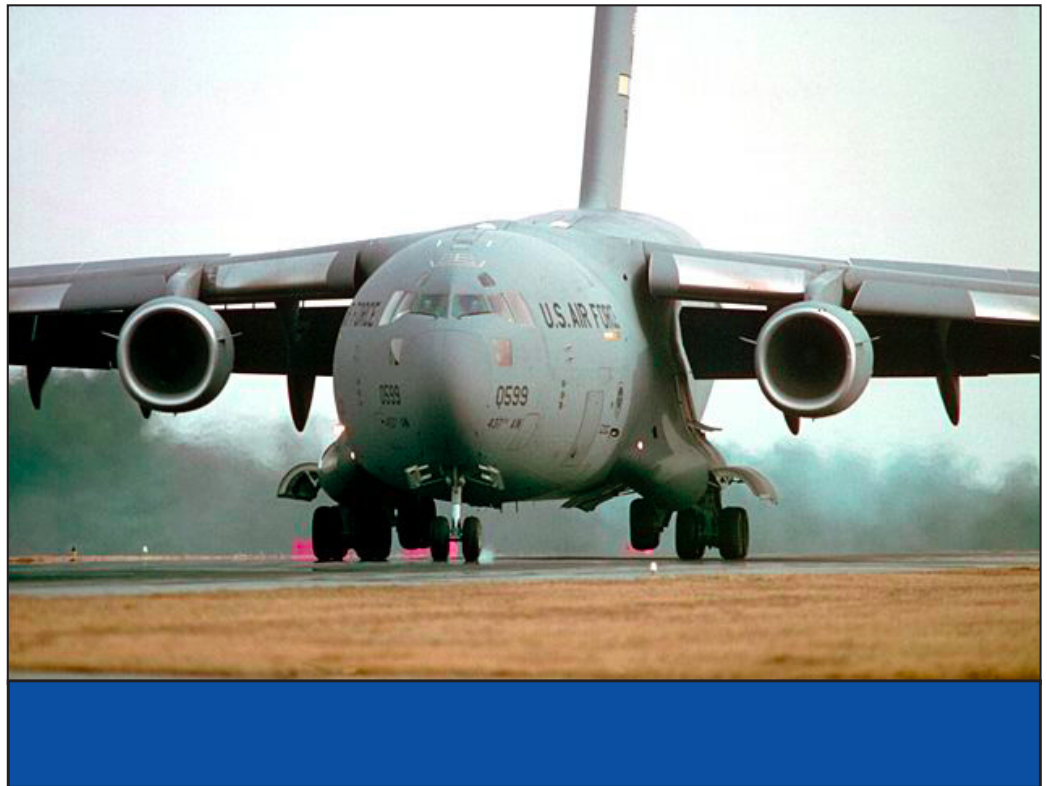
Rapid deployment of a fix for C-17 landing gear problems eliminated a major operational and safety concern in the C-17 fleet and will provide the Air Force a cost avoidance of more than \$500,000 for each failure eliminated. Elimination of this failure mode also increases mission readiness.

Directorate engineers determined the trunnion collar, a mechanism that keeps the 10 ft long, 800 lb gear straight with the wheel well, to be the problem. Threads cut in the trunnion collar, where a fatigue flaw initiated, use a non-standard "buttress" thread cut. Engineers use the buttress cut, designed for axial loads, when the applied loading is primarily in one direction.

Directorate engineers found this type of cut produced a high-stress concentration located at the thread root that causes fatigue crack initiation. To prevent fatigue initiation, the collar required a more uniform stress distribution, so the engineers recommended a larger root radius thread.

Procedures developed by the materials engineers helped the Air Mobility Command implement the fix on the entire fleet in just six weeks. Long term, the program office will field a further enhanced trunnion collar, incorporating both the gentler root radius threads as well as an increased cross-sectional area.
